# **Central Europe Floods of September 2024**

Event Update as of September 16

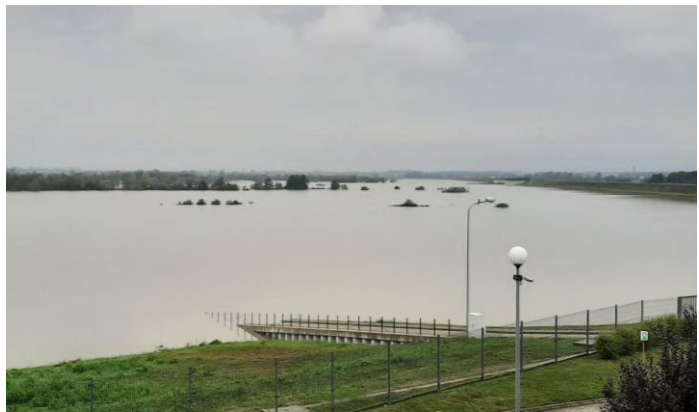
The 1997 flood, known in **Poland** as *Powódź tysiąclecia* (Millenium Flood) similarly led to further investments into flood protection in the region. One of the examples is the Racibórz Dolny polder with a capacity of 185 million cubic meters (image on the right), constructed in 2020, the largest water management structure in Poland. On September 15-16, 2024, it started taking in water from the Odra catchment and protecting exposure downstream, including Wrocław.

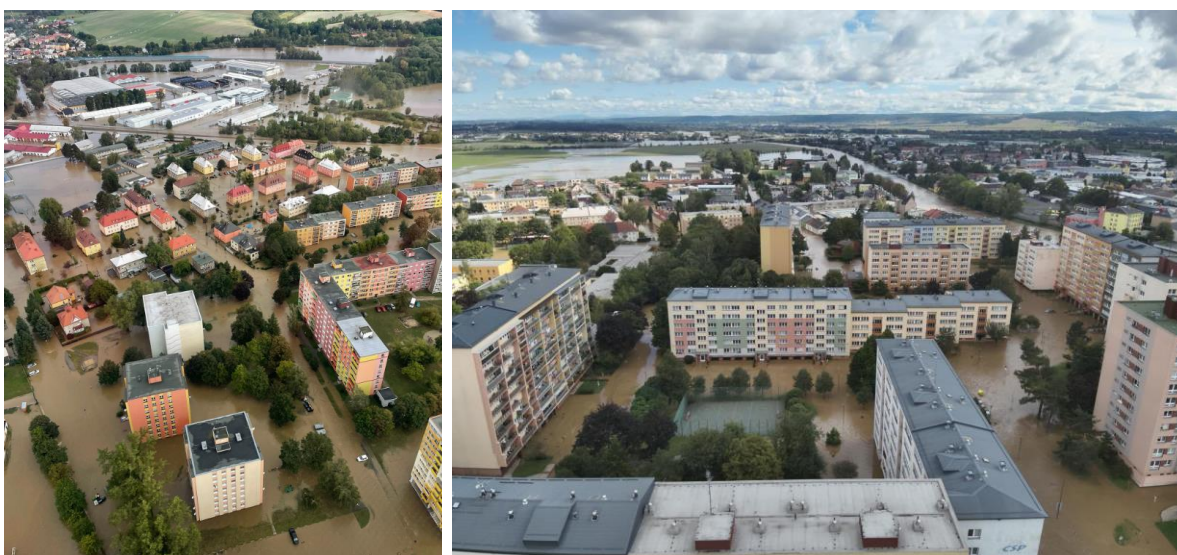
The situation gradually deteriorated over the weekend following the continuous rain and on September 15, 250 locations reported flood stage, of which 120 exceeded the third, highest level. The worst situation was in Olomouc and Moravian-Silesian regions, particularly in Jeseníky, Opava and Ostrava areas, where **Opava River** reached 1-in-100-year discharges and **exceeded levels recorded during the catastrophic flood of 1997**. Multiple towns and municipalities were partly or completely flooded – notably, roughly 80% of the town of Krnov, or residential neighbourhoods on the left-bank parts of Opava were under water. **Odra River** culminated and flooded parts of the city of Ostrava.

**Town of Krnov (left) and Kateřinky neighborhood of left-bank Opava (right), both flooded by the Opava River.**

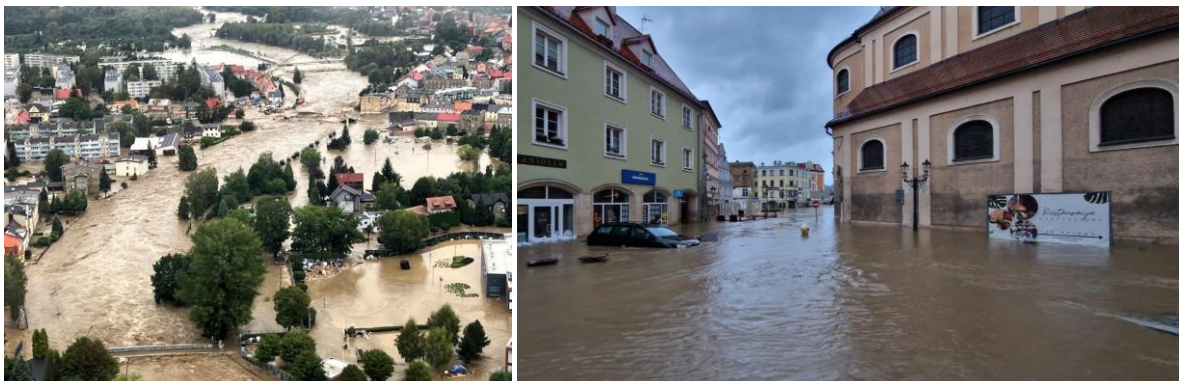
Critical situation occurred in Stronie Ślonskie, where a small reservoir collapsed on September 15, sending a large flood wave downstream and essentially flooding the entire town. Widespread damage occurred in the town of Głuchołazy, with a temporary bridge destroyed and large areas under water. The town was similarly affected during the Millenium flood of 1997. Further downstream, town of Nysa was notably affected. Critical situation also developed in the Kłodzko area, in Łądek-Zdrój and elsewhere.

**Catastrophic flood in Głuchołazy (left) and Kłodzko (right)**
